## Failure Analysis.

## Student 2: Failure Analysis

### Common Problems

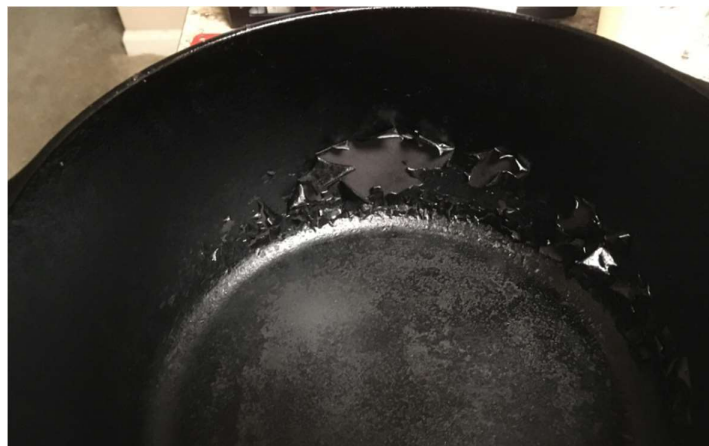
Non-stick frying pans having PTFE (Teflon) coating are prone to various problems that affect their performance and durability. One of the major problem is coating peeling, which refers to shedding, scaling, or fall-down of the coating layer [1]. The non-stick coating may start to degrade and eventually start peeling-off due to continued use, particularly when the pan is subjected to high temperatures or when it is not used properly, e.g., when it is used with metallic utensils. Coating peeling does not only impact the non-stick properties, it is also poses dangerous health risks when ingested [1].

*Figure 1: Peeling of the non-stick coating layer of the pan*

Improper use or inadequate maintenance of the pan leads to these problems. The peeling of the coating occurs when the pan is exposed to high temperatures, and especially when oil is used, which may get hot within a short time. Although the coating, which is made of PTFE, is heat-resistant, it can only withstand heat up to a specific temperature before starting to break-down.

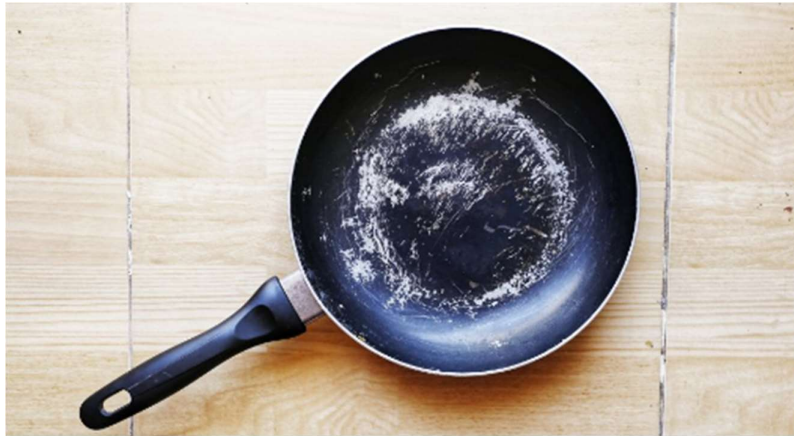
The other problem is scratches, which refers to surface damage that occurs when abrasive materials, such as sharp metallic utensils like forks and spoons, or rough cleaning pads scrub the surface of the pan [2]. Scratches weaken and destroy the non-stick layer, making the pan vulnerable to food sticks and more difficult to clean.

*Figure 2: Scratches due to use of abrasive materials*

Scratches on the other hand are caused by the user, particularly when they use sharp metal utensils or rough scrubbing tools that unintentionally remove the protective coating [2]. Scratches damage the non-stick coating and makes it less effective.

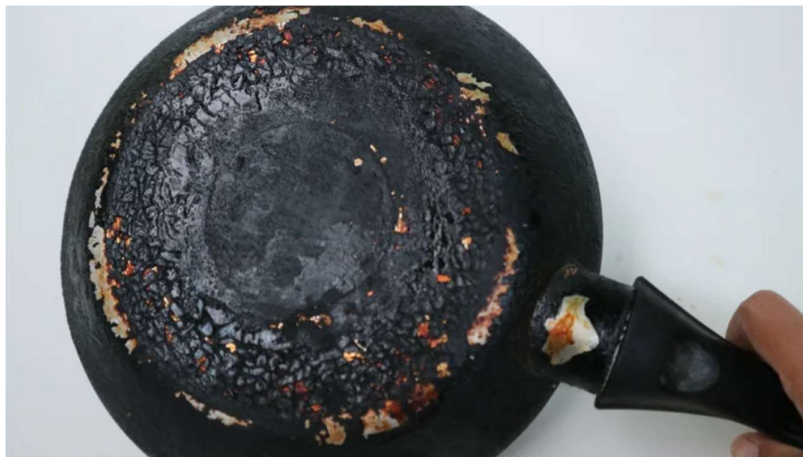
Another significant problem is heat damage, where too much heat can lead to breakdown of the non-stick coating as well as warping of the material used to make the pan [2]. Also, besides structural or functional damage, prolonged overheating, particularly with temperatures above 260°C can lead to emission of dangerous fumes, and consequently reduce the lifespan of the pan.

*Figure 3: A pan damaged by excessive heating*

Heat damage is caused by heating the pan to temperatures higher than the recommended, or when the pan is left empty on a hot burner for too long, making the coating wear away.

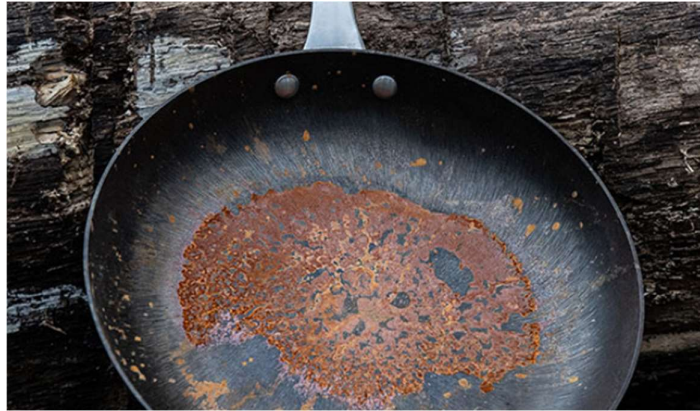
Corrosion, occurring in the form of rusting or deterioration of metal components, is also a common problem that frequently affects the stainless steel handle of the pan or sections of the base that are exposed to moisture or acidic food [1], [3]. Although PTFE is not susceptible to

corrosion, some metal components of the pan can start to rust or corrode in harsh environments, which creates problems with the pan durability.

*Figure 4: A corroded pan with rust*

Corrosion, although less frequent to non-stick surfaces, occurs when the pan is exposed to moisture and acidic foods over an extended periods of time, resulting in rusting of the metal parts, particularly when the pan is not dried or stored properly after washing [3].
